# *1st Defense Home Inspections, LLC*

## Property Inspection Report

1234 snoopy, north pole, FL

Date of Inspection: 3/27/2013 Time: 1 PM

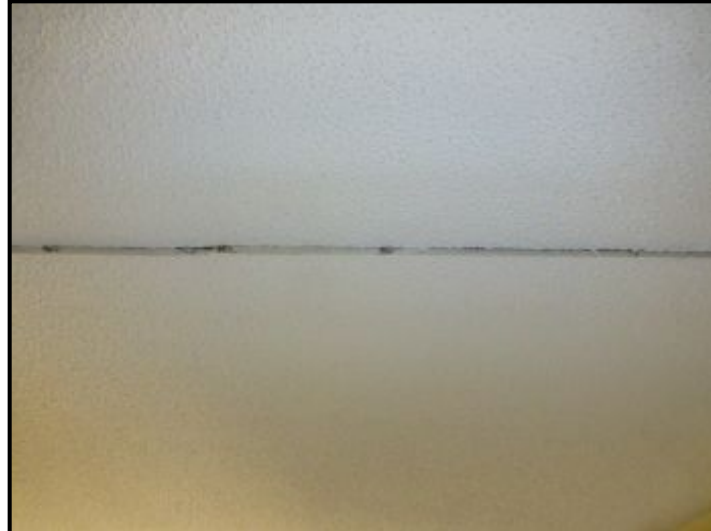
- Evidence of past leaking was noted.
- Living room ceiling has separated at the drywall seam. Have repaired as necessary.

Living room ceiling has separated at the drywall seam. Have repaired as necessary.

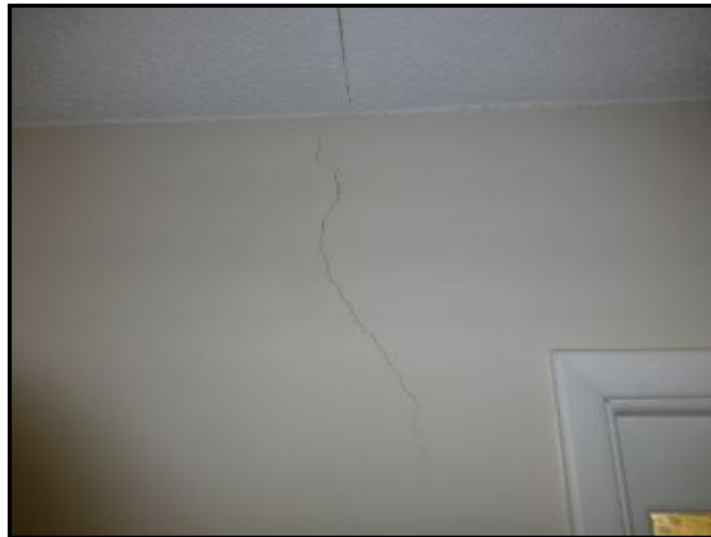
- Large crack forming down the front room wall by the entry door. Suggest having a structural engineer evaluate further.

Large crack forming down the front room wall by the entry door. Suggest having a structural engineer evaluate further.

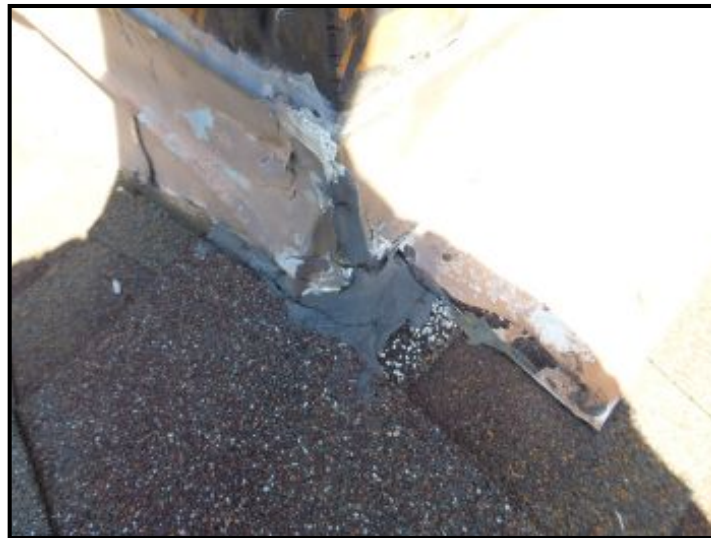
- Flashing at base of chimney appears to need some maintenance to ensure a continued waterproof seal.

Flashing at base of chimney appears to need some maintenance to ensure a continued waterproof seal.

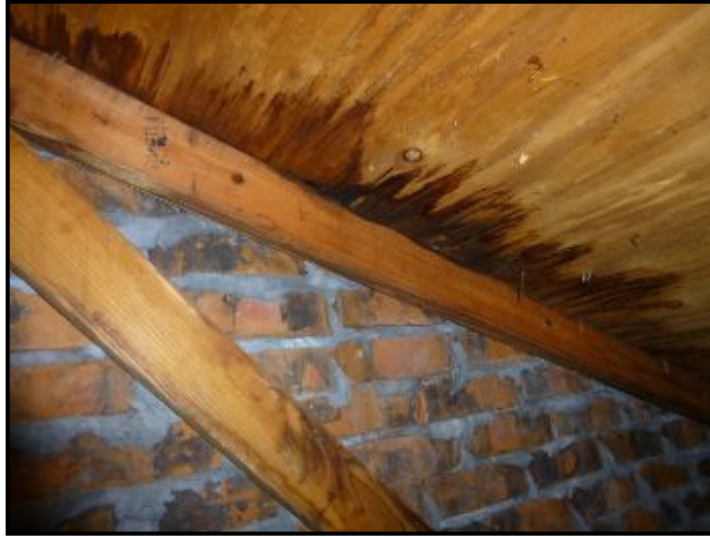
Observations:  
 • Evidence of past or present leaks, dry at time of the inspection. Monitor for leaks &/or have roofing contractor evaluate.

Evidence of past or present leaks, dry at time of the inspection. Monitor for leaks &/or have roofing contractor evaluate.

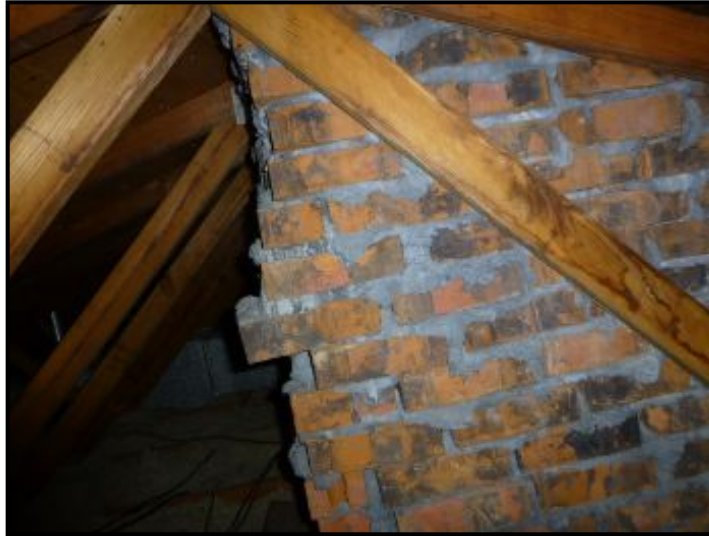
- Brick and mortar deterioration observed; repair advised.

Brick and mortar deterioration observed; repair advised.

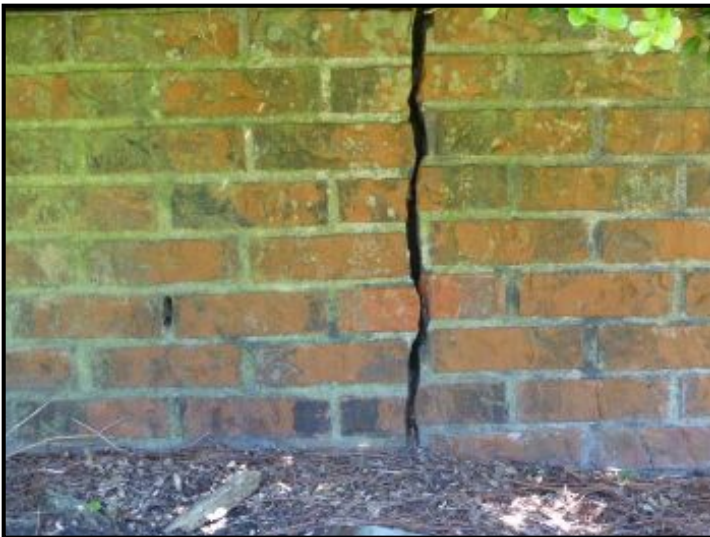
- Large cracks were observed at the visible foundation walls. Repairs can be expensive and further settling or damage could occur. Recommend a Structural Engineer to provide a detailed analysis.

Large cracks were observed at the visible foundation walls. Repairs can be expensive and further settling or damage could occur. Recommend a Structural Engineer to provide a detailed analysis before the close of escrow on the structure.

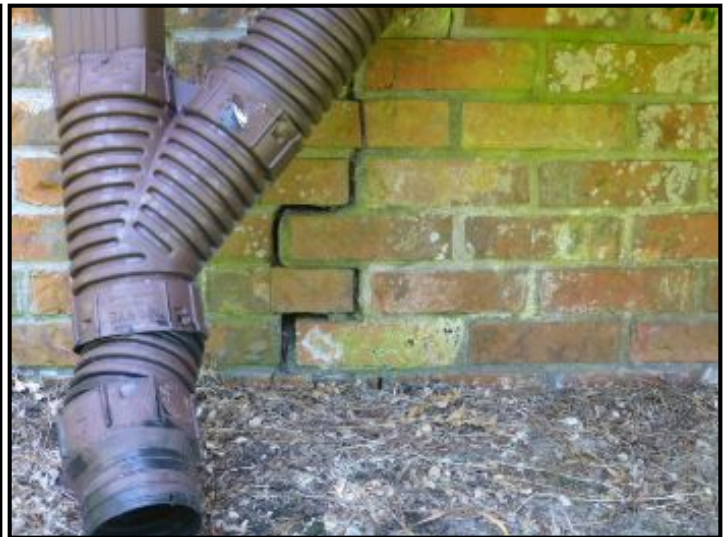
Large cracks were observed at the visible foundation walls. Repairs can be expensive and further settling or damage could occur. Recommend a Structural Engineer to provide a detailed analysis before the close of escrow on the structure.

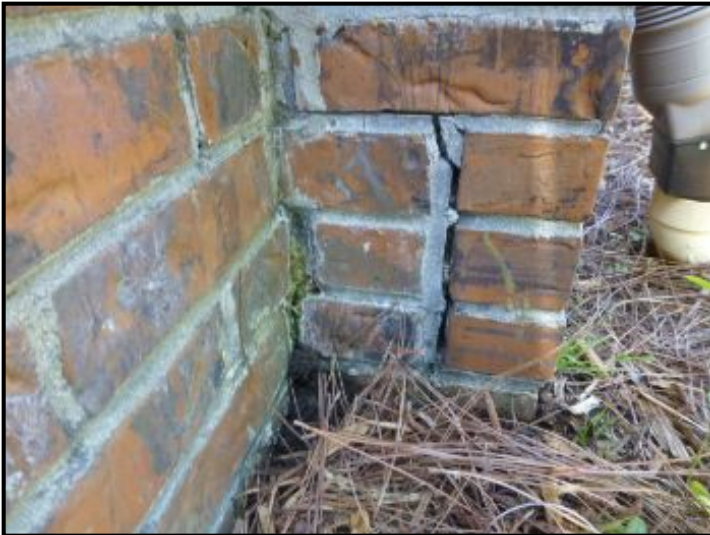
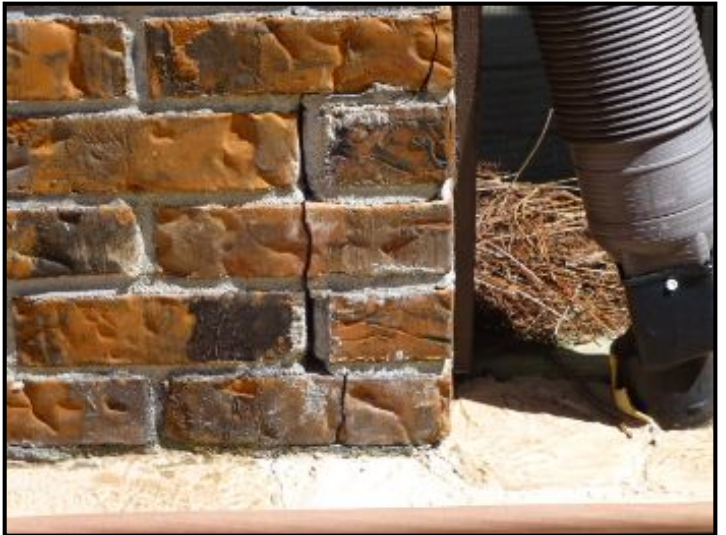
Large cracks were observed at the visible foundation walls. Repairs can be expensive and further settling or damage could occur. Recommend a Structural Engineer to provide a detailed analysis before the close of escrow on the structure.

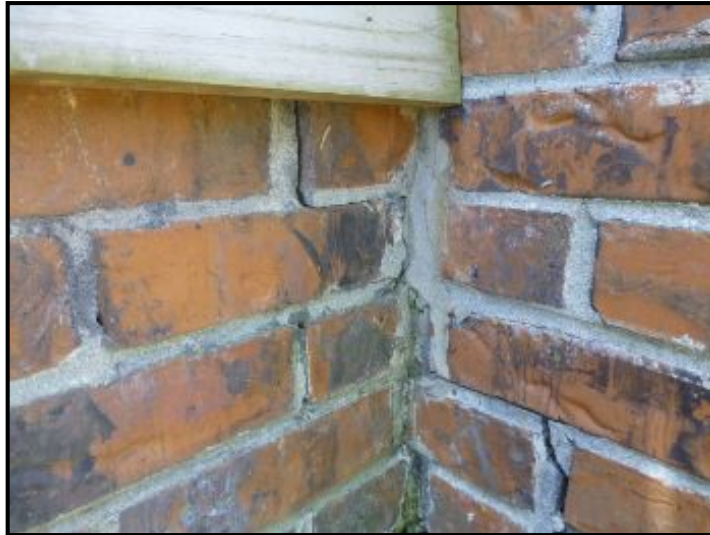
Large cracks were observed at the visible foundation walls. Repairs can be expensive and further settling or damage could occur. Recommend a Structural Engineer to provide a detailed analysis before the close of escrow on the structure.

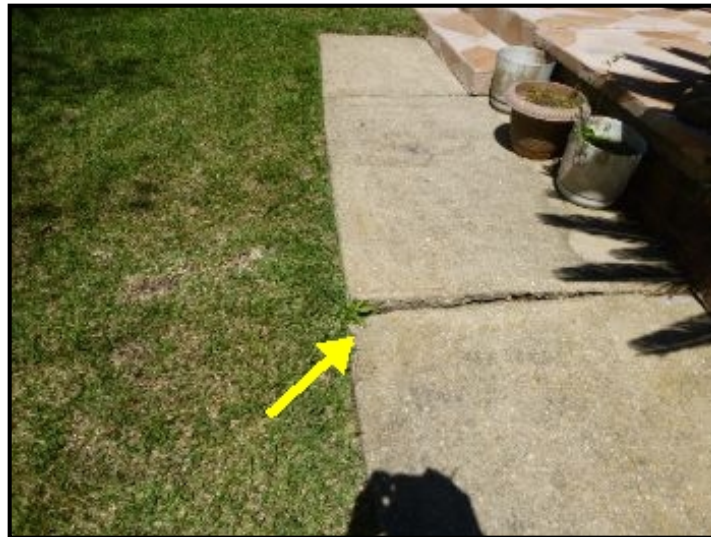
- Several large trees on the lot that are causing root uplift on cement sidewalk and possible structural issues.

Several large trees on the lot that are causing root uplift on cement sidewalk and possible structural issues.

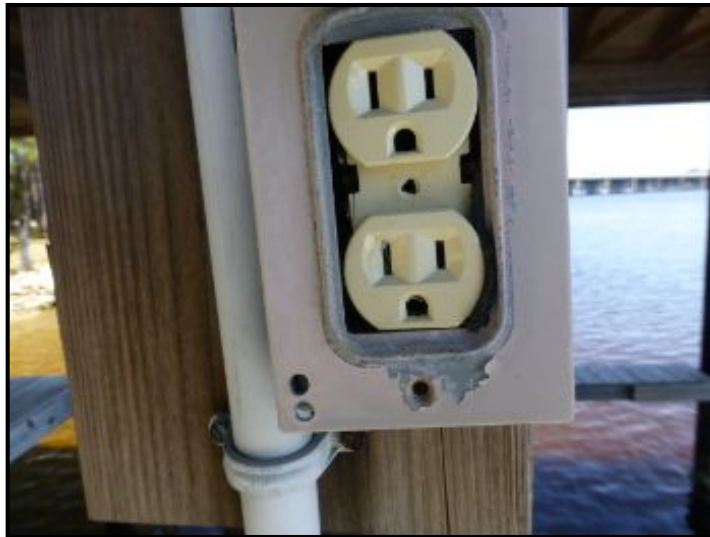
- outlet on boat dock does not have a weatherproof seal.

outlet on boat dock does not have a weatherproof seal.

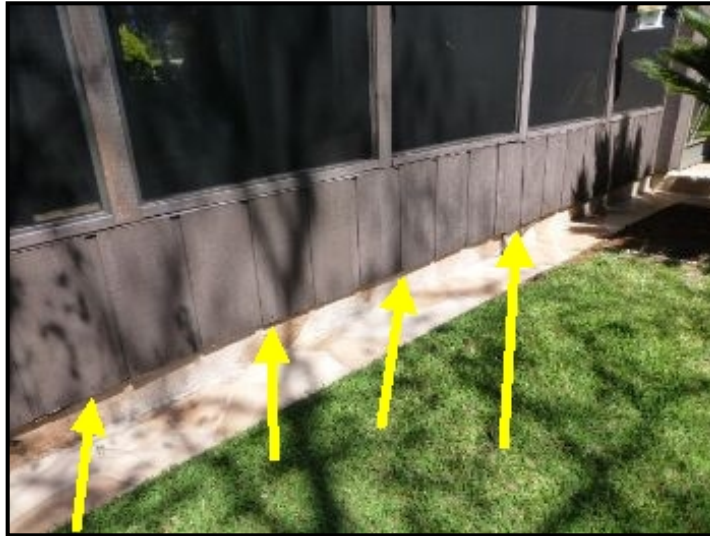
• **Rotted Wood.**

Rotted Wood.
